Reusable Solid Rocket Motor—Accomplishments, Lessons, and a Culture of Success

Dennis R. Moore¹ and Willie J. (Jack) Phelps²
Marshall Space Flight Center, Huntsville, State, AL, 35812

Abstract: The Reusable Solid Rocket Motor represents the largest solid rocket motor ever flown and the only human rated solid motor. Each Reusable Solid Rocket Motor (RSRM) provides approximately 3-million lb of thrust to lift the integrated Space Shuttle vehicle from the launch pad. The motors burn out approximately 2 minutes later, separate from the vehicle and are recovered and refurbished. The size of the motor and the need for high reliability were challenges. Thrust shaping, via shaping of the propellant grain, was needed to limit structural loads during ascent. The motor design evolved through several block upgrades to increase performance and to increase safety and reliability. A major redesign occurred after STS-51L with the Redesigned Solid Rocket Motor. Significant improvements in the joint sealing systems were added. Design improvements continued throughout the Program via block changes with a number of innovations including development of low temperature o-ring materials and incorporati

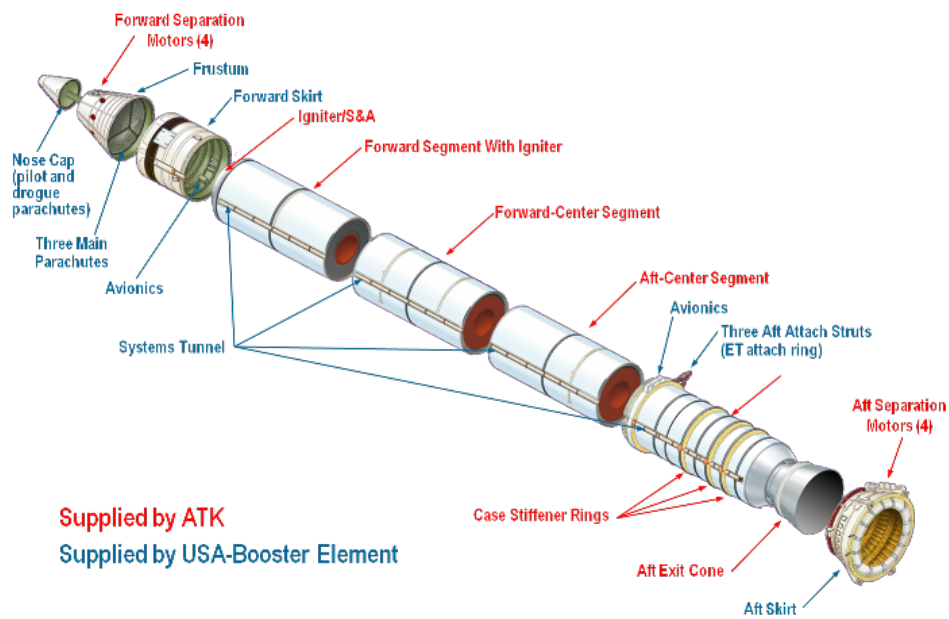
Figure 3. SRB/SRM detail.

As of this date, the Space Shuttle Reusable Solid Rocket Motor (RSRM) was the largest diameter solid propellant motor used for space flight and the only large solid rocket motor (SRM) certified to launch humans into space. The RSRM basically consisted of four propellant-loaded steel case segments (forward, forward-center, aft-center, and aft) with a binding liner and thermal protecting insulation, a head end igniter system with a safe and arm device, and a multicomponent metal nozzle structure with thermal protecting carbon phenolic liners. The propellant mixture consisted of aluminum powder (fuel), ammonium perchlorate (oxidizer), iron oxide (burn rate catalyst), epoxy curing agent, and a polymer binder that held the mixture together. An assembled motor was 126 ft long, 12 ft in diameter, and contained approximately 1.1-million lb of propellant (Figs. 1 and 2). At lift-off of the Space Shuttle, the two RSRMs provided 6.6-million lb thrust—the RSRMs provided 80% of the Space Shuttle lift-off thrust. Figure 3 is a graphical depiction of the SRB/RSRM detail.

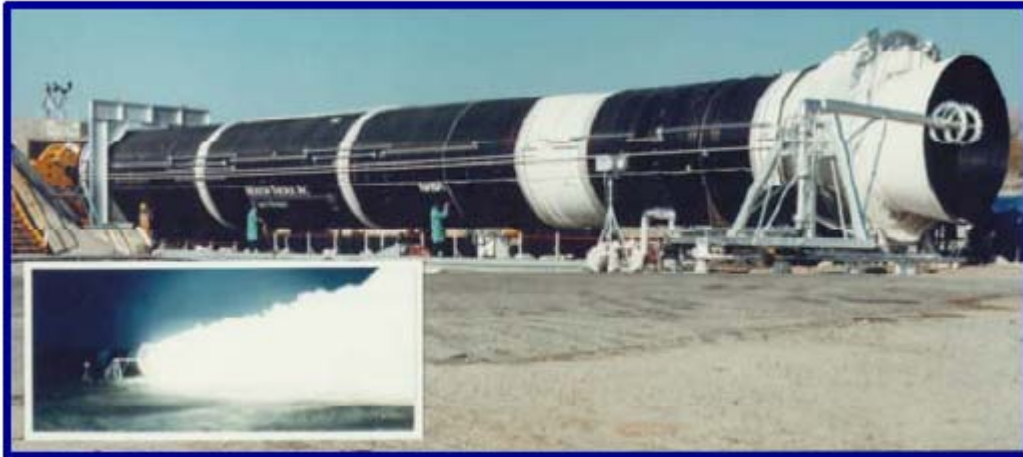
Figure 6. DM-7.

Two full-scale static tests, DM-6 and DM-7, were conducted in October 1984 and May 1985. A full-scale FWC Qualification Motor (QM-5) was assembled and ready to fire when the Challenger accident occurred. At that time, the first FWC flight motors were stacked and ready to support a July 1986 launch at the Vandenberg launch site in California. The FWC development and the plans to launch the Space Shuttle out of Vandenberg were subsequently abandoned.

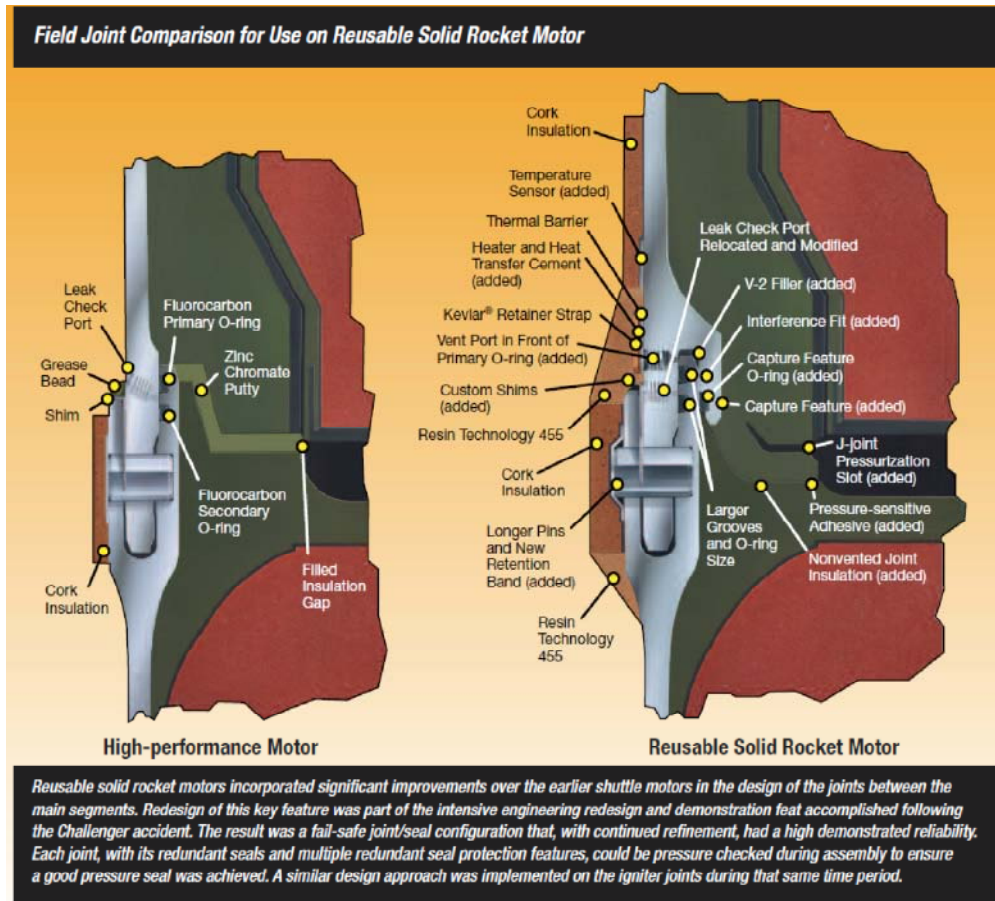
Figure 8. Field joint comparison.

stop the flow of gas into the joint. The selected design (Fig.8) added a J-leg to the tang-side insulation with matching clevis side insulation and included pressure sensitive adhesive to act as a sealing and bonding agent for the mating surface.³ Figure 12 shows how the pressure-assisted insulation J-leg works.

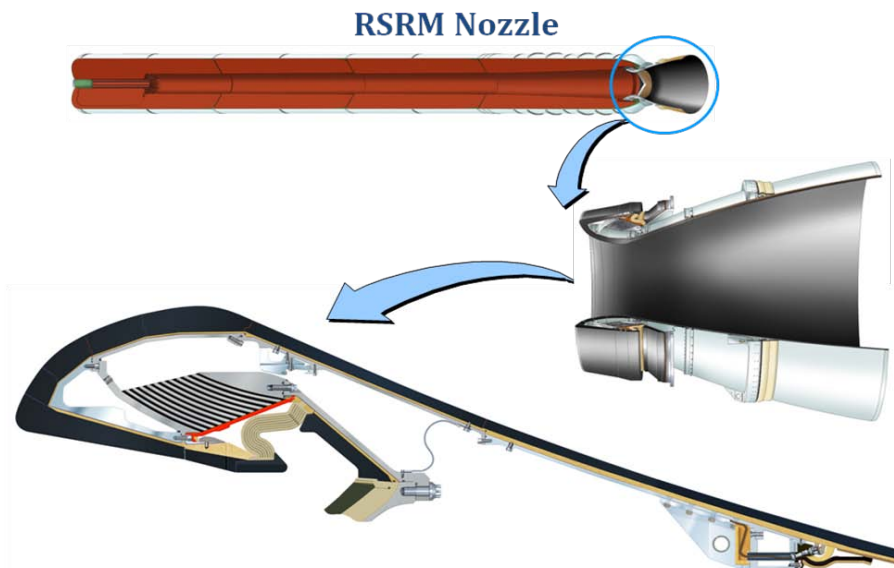
Figure 9. RSRM nozzle.

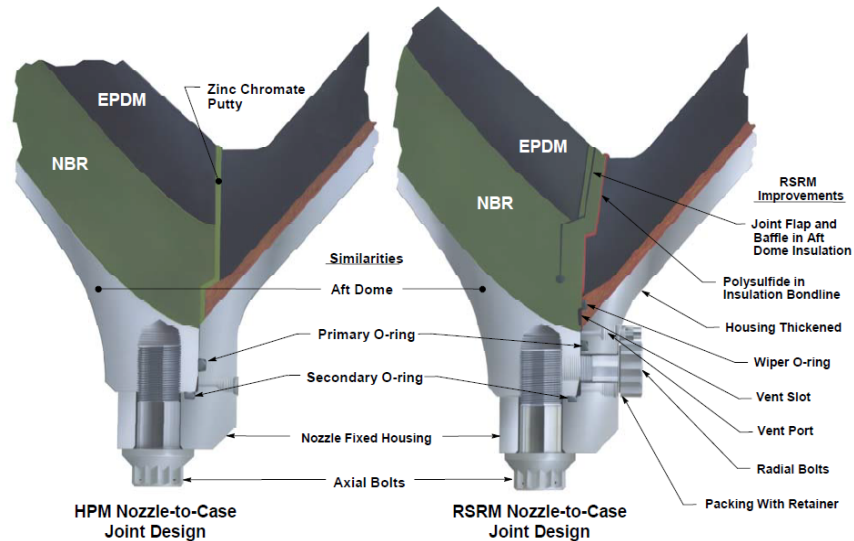
Figure 10. HPM and RSRM joint design.

Shortly after return-to-flight, an insulation J-leg thermal barrier was developed for the igniter inner and outer joints (Fig. 10).

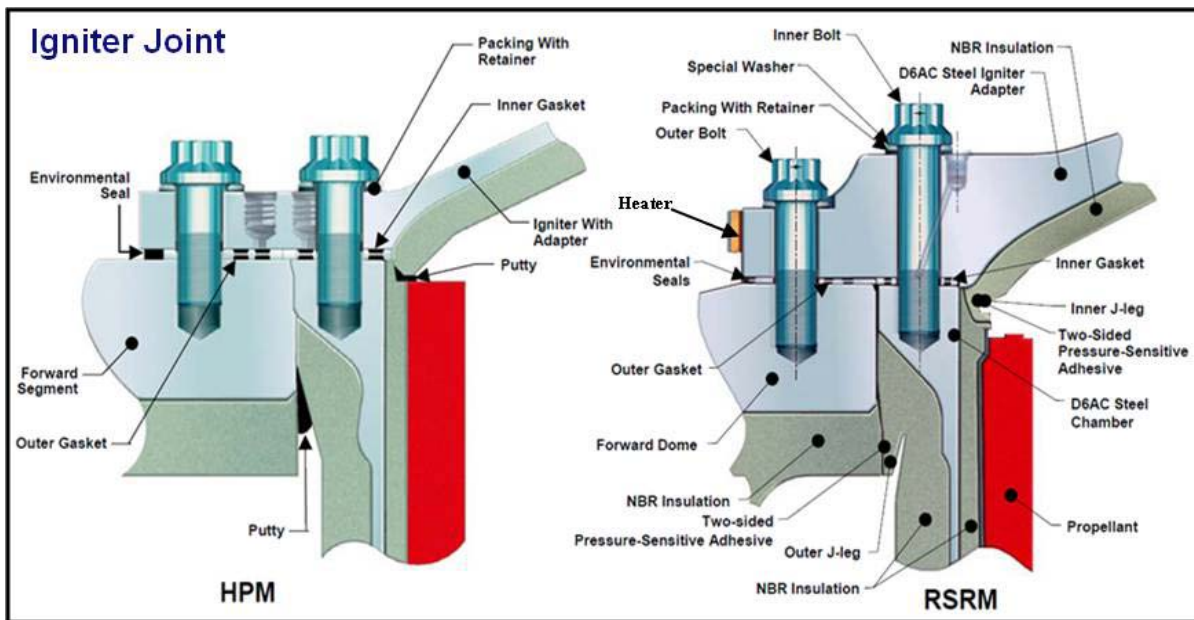
Figure 11. HPM and RSRM igniter comparison.

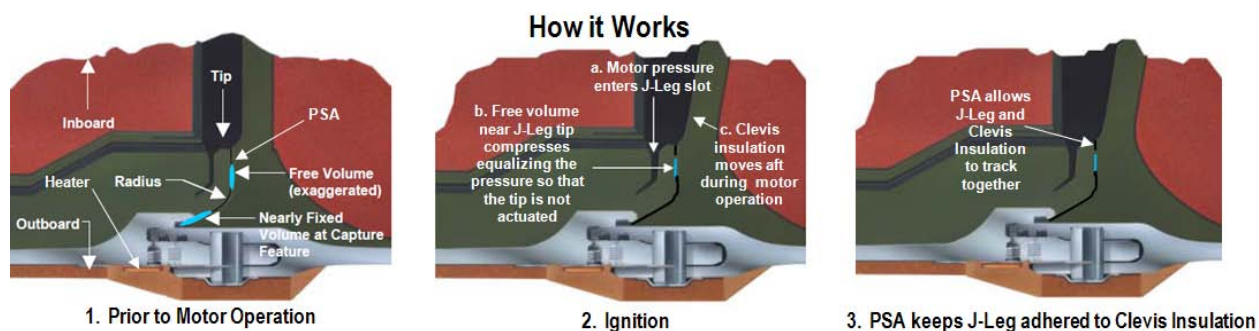
At ignition, motor gas enters the J-leg slot and with the aid of the pressure sensitive adhesive the J-leg tracks the clevis insulation keeping hot gas away from the downstream o-rings. This design was first used on RSRM-1 (STS-26R). Although it was considered a thermal barrier and not a seal, this design proved to be very successful, and except for the RSRM-55 (STS-78) special cause, never allowed gas into the joint. RSRM-55 used a new water-based PSA whose properties were adversely affected by the high humidity conditions during application at KSC; the fix was to switch back to the previously used methyl chloroform based PSA. The successful performance of the J-leg in the field joint eventually led to the incorporation of this design feature into the igniter inner and outer joints, and the nozzle-to-case joint.

Figure 12. Pressure-assisted insulation J-leg.

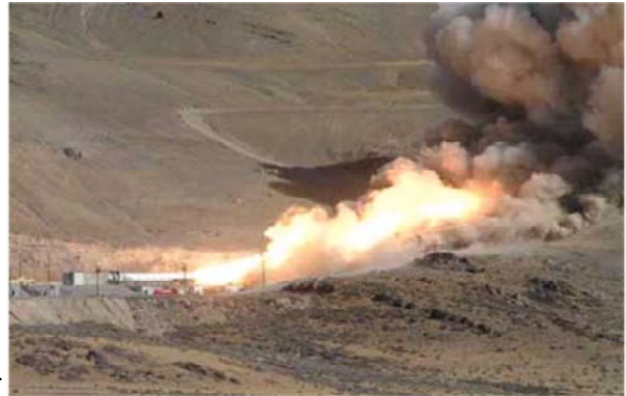
Figure 13. ETM-3 static test, October 23, 2003.

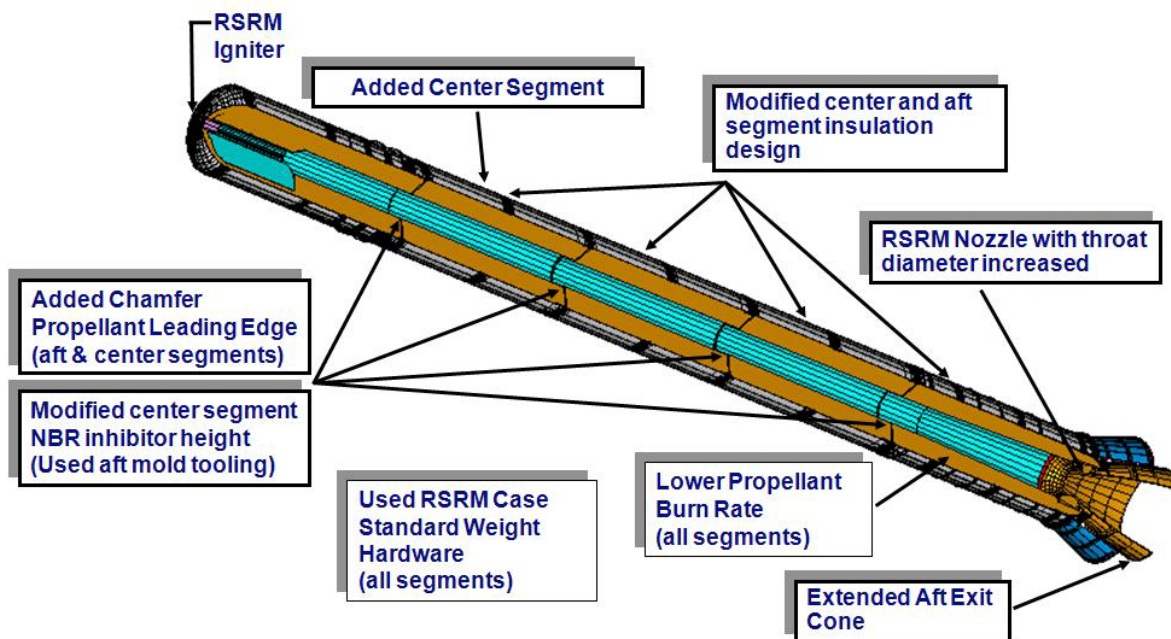
ETM-3 (Fig. 14) included the following changes from the RSRM four-segment motor design: 1) added center segment (added 273,000 lb of propellant over the RSRM), 2) bored out nozzle throat, 3) reduced burn rate propellant, 4) extended aft exit cone, 5) added chamfer to propellant leading edges, 6) modified center segment rubber inhibitor heights, and 7) modified center and aft segment insulation design. ETM-3 was instrumented with 620 gauges and a total of 635 channels.

Figure 14. ETM-3 modifications from RSRM.

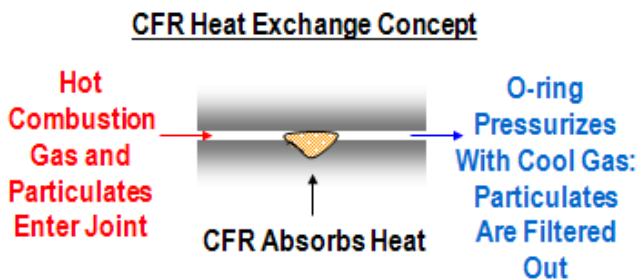
Figure 15. Carbon fiber rope function.

In the late 1990s researchers at the NASA Glenn Research Center (GRC) were experimenting with braided carbon fiber rope and discovered that it had the ability to remove most of the thermal energy from a high temperature gas that passed through it without much noticeable damage after several minutes of exposure. The rope is very permeable and the high heat capacity of the carbon fibers allows for the efficient removal of heat (Fig. 15).

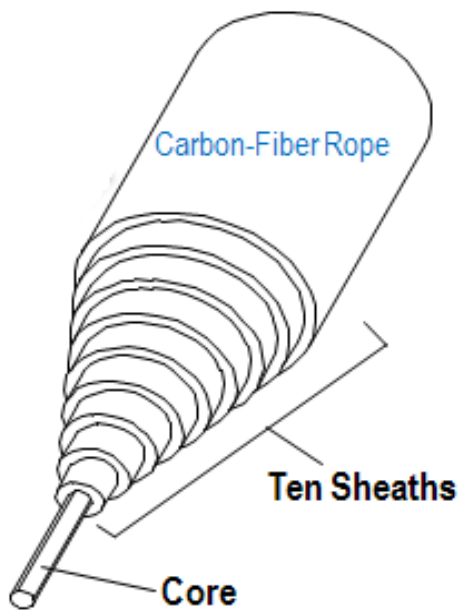
Figure 16. Carbon fiber rope.

in RSRM applications. The final rope design consisted of a carbon fiber center core surrounded by ten sheaths of braided carbon fiber (Fig. 16).

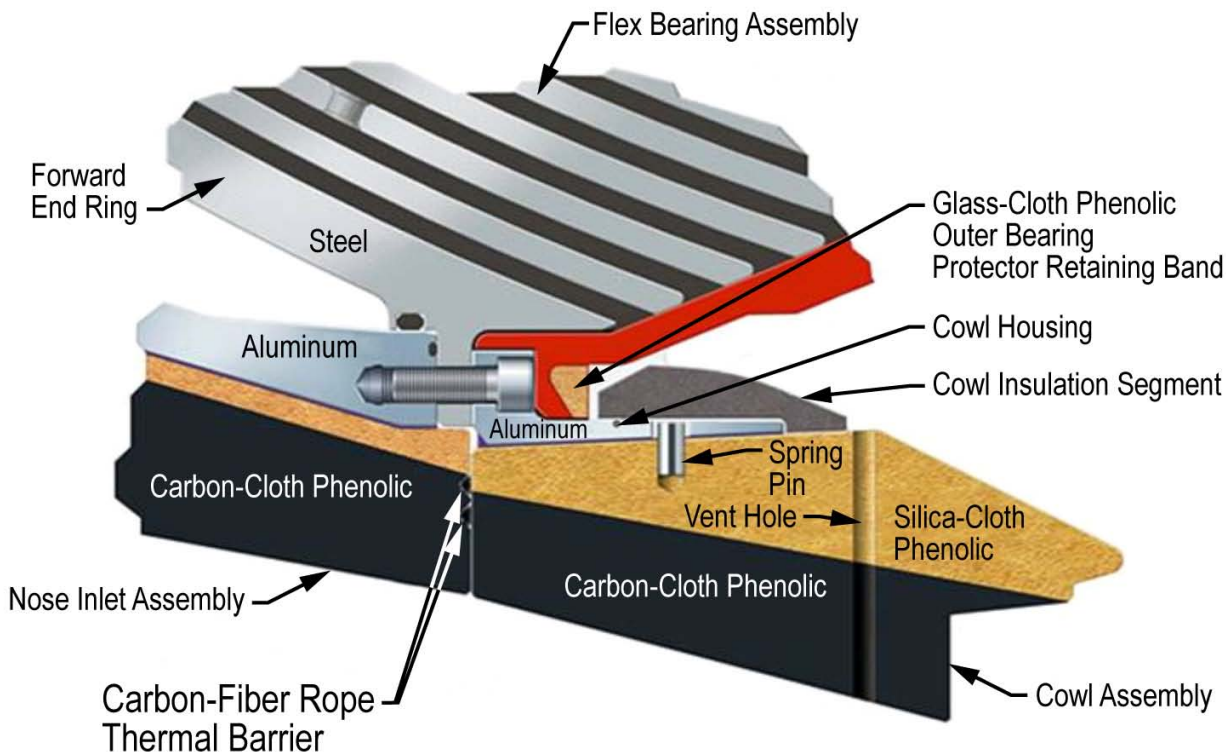
Figure 17. Nozzle joint 2.

ATK and NASA developed nozzle design solutions for these thermal barrier gas paths that utilized the heat dissipating qualities of the carbon fiber rope (Figs. 17, 18, and 19).

The nozzle joint 2 and 5 designs eliminated the RTV thermal barriers (open volume allowed gas to fully pressurize the joint at ignition) and placed carbon fiber ropes upstream of the o-ring seals, cooling the hot combustion gases that passed through them to temperatures close to ambient. As an example of how well the new designs performed, photos of the typical joint 2 condition before and after incorporation of the carbon fiber rope design is shown in Figure 20. The nozzle-to-case joint design incorporated an insulation j-leg thermal barrier and downstream carbon fiber rope ahead of the o-ring seals that protected them from high temperature exposure in case the J-leg leaked. All incorporated carbon fiber rope designs eliminated thermal barrier gas paths and performed flawlessly after their incorporation on flight hardware.

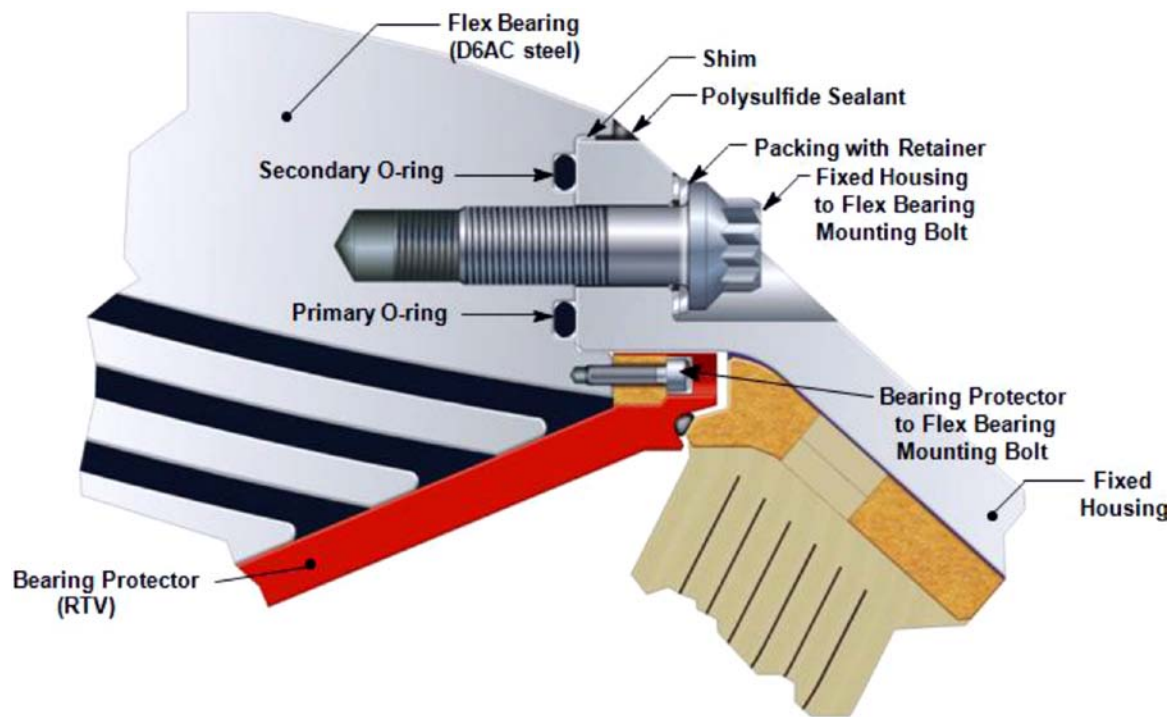
Figure 18. Nozzle joint 5.

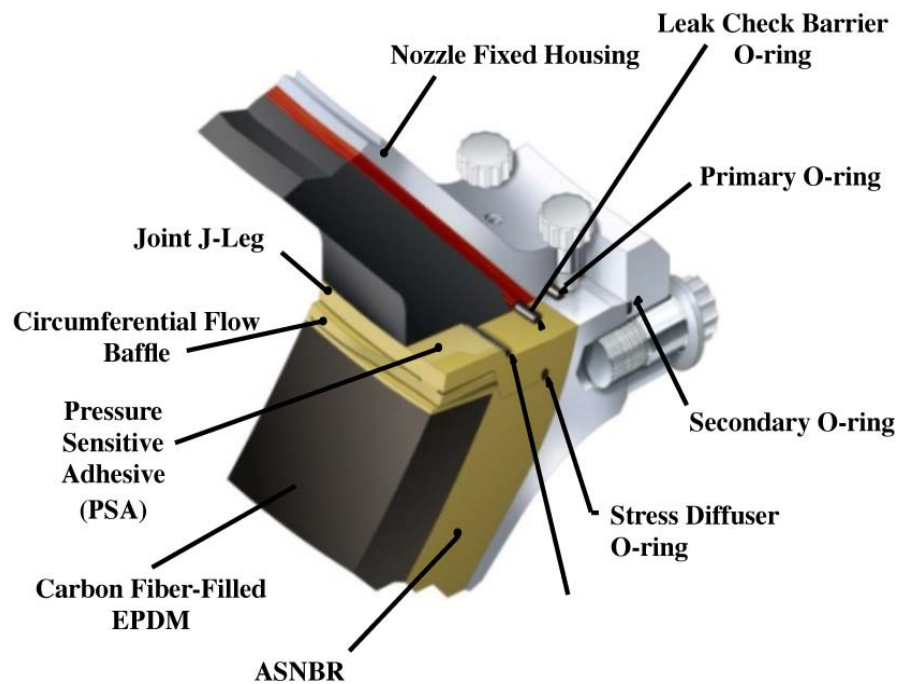
Figure 19. Nozzle-to-case joint.

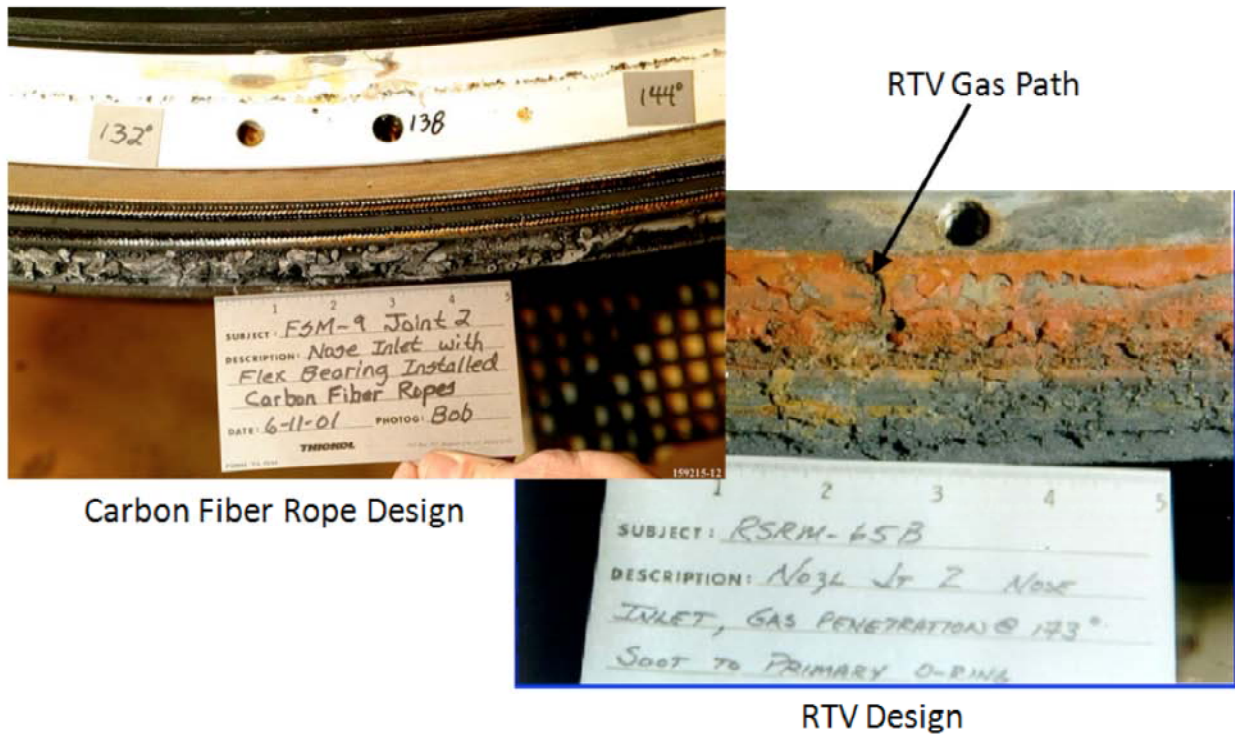
Figure 20. Joint 2 RTV and carbon fiber rope design comparison.

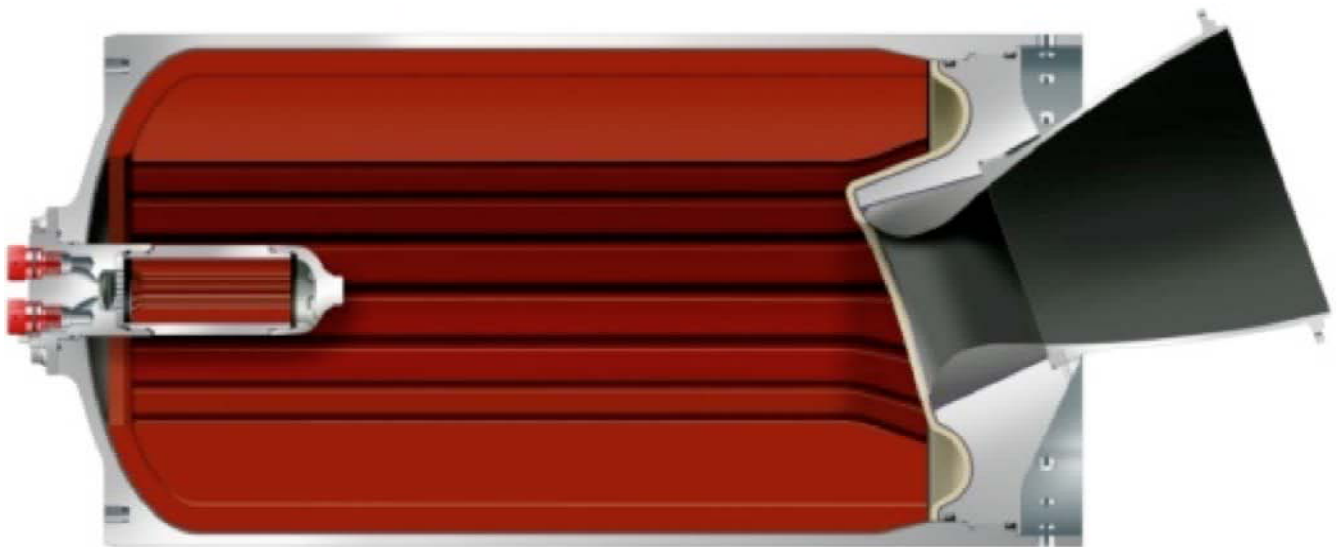
Figure 21. The ATK BSM.

The original shuttle BSM was designed by United Technologies Corporation, Chemical Systems Division (CSD). This design flew on the first 120 Shuttle missions. In October 2003, ATK received an alternate source contract to develop BSMs with selected design and processing upgrades to further enhance motor reliability. The ATK design was heavily based on the CSD design with specific enhancements based on RSRM design practices and modern analytical approaches. The ignition system was completely redesigned to address lessons learned from an investigation of erratic ignition pressures conducted by CSD, ATK, and NASA. Other components of the motor remained essentially unchanged from the CSD design with minor adjustments made to address obsolescence concerns and lessons learned during the baseline flight program. Improvements introduced with the ATK BSM (Fig. 22) included: (1) ATK manufactured only one motor configuration (at KSC, United Space Alliance performed the necessary BSM closeout depending on whether the BSM was mounted in the forward or aft position), (2) sling lined chamber (CSD was hand applied), (3) ATK BSMs were cast in batches of four motors rather than the 64 by CSD, (4) the design used a new stronger adhesive (TIGA), (5) redesigned graphite throat with improved margins, (6) interchangeable case and aft closures eliminated matched sets (7) incorporated new better resiliency low temperature o-rings, (8) increased o-ring squeeze, (9) added an igniter-to-case leak check port, and (10) redesigned igniter. During the development program for the ATK designed BSMs, CSD announced closure of the San Jose, CA facility that produced BSMs. This revelation led NASA to a sole source contract with ATK to manufacture the BSMs and eventually to the first flight of ATK BSMs in the forward position on STS-122 and in all positions on STS-126). All ATK BSMs exhibited excellent performance through the end of the Shuttle Program.

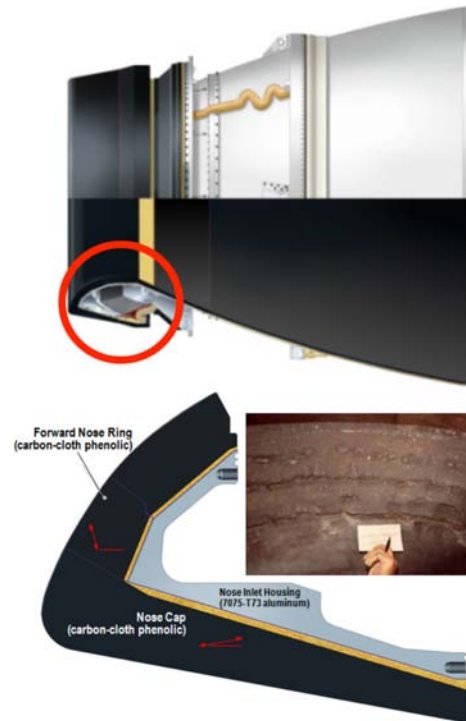
Figure 22. Nozzle pocketing.

During the eighth Space Shuttle flight (STS-8), the carbon cloth phenolic (CCP) ablative rings on the forward nose of one of the nozzles (Fig. 22) exhibited a severe rate of material loss referred to as “Pocketing.”⁴ The ablative rings form the contour of the nozzle and protect the underlying metal structure from the super-hot exhaust gases. At the end of a nominal motor burn (123 s), there is usually enough material remaining to fire the nozzle a second time. However, the erosion rate on STS-8 was so great that only 8 seconds of ablative material remained. When carbon/phenolic plies are incorrectly oriented to the flow surface, stresses can exceed the hot charred material strength resulting in anomalous erosion.

Before the Challenger accident, in both flights and static firings, there had been eight pocketing events in 66 nozzles at the nose inlet and one pocketing event in 66 nozzles at the nozzle throat. The problem of pocketing at the nose inlet was completely eliminated with the ply angle change that occurred with the first RSRM flight. Over the next 9-plus years there were zero pocketing events on 170 nozzles. On the RSRM 56B nozzle (Sep. 96), both the RSRM 49A and RSRM 49B nozzles (Nov. 96), and the RSRM 57B nozzle (Aug. 97) throat ring nozzle pocketing returned with accompanying downstream erosion. Because of this problem, a significant effort to understand the nozzle pocketing began. This effort, which involved a widespread technical community, was referred to as an enhanced sustaining engineering (ESE) effort; fault tree methodology was used

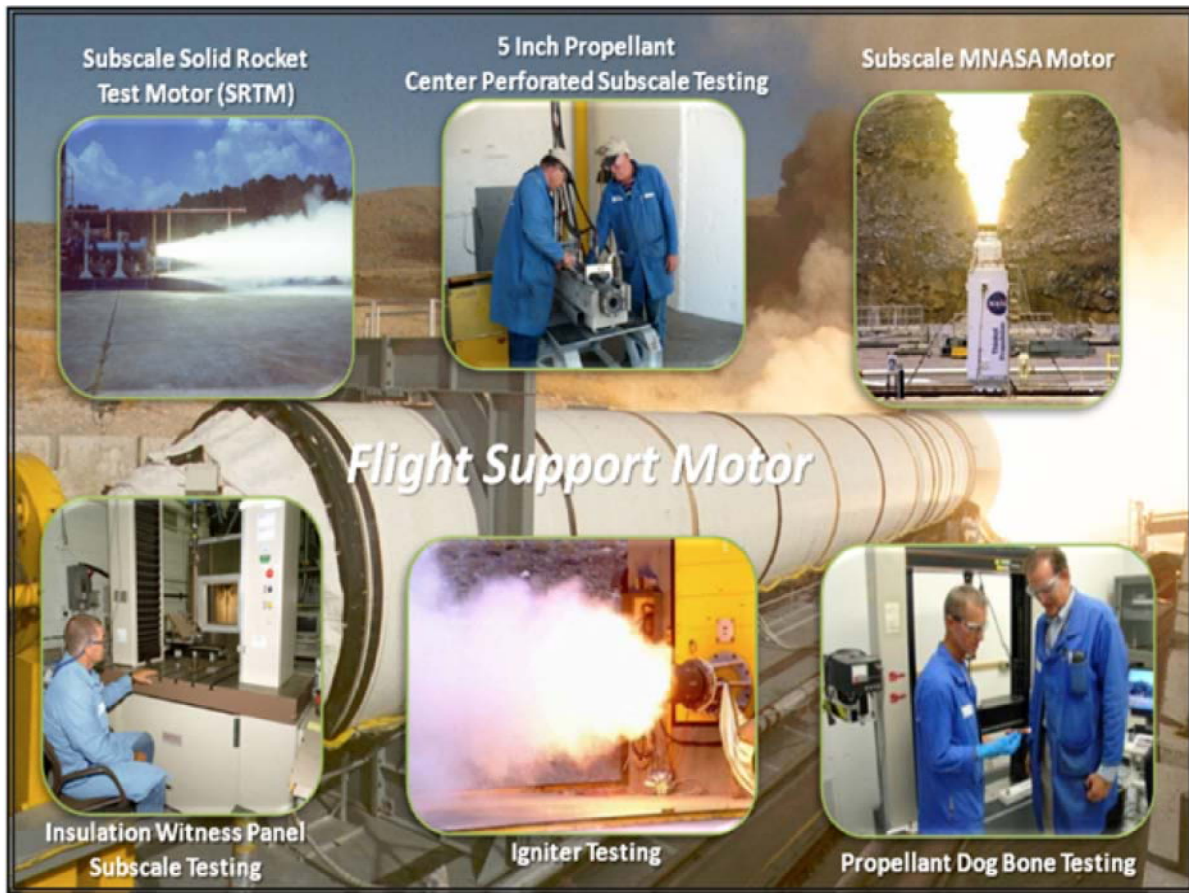
Figure 24. RSRM testing.

Subscale testing covers the entire spectrum of tests that range from the dog-bone type tensile tests of propellant batches, witness panel peel and tensile testing of insulator materials that follow all flight hardware processes to small scale motor tests that include a 5-inch diameter Center Bore (5-in. CP) used to get propellant burn rate, and larger motor tests like the 70-lb char motor to evaluate insulation performance, the 24-inch diameter Solid Rocket Test Motor (SRTM) used to screen design or material change concepts and the 48-inch diameter MNASA Modified NASA Motor (MNASA) used for further screening and to check expected performance on a motor that closely resembles the RSRM (Fig. 24). The highest level test is the full-scale Flight Support Motor (FSM), a true replicate of the RSRM flight motor, but very highly instrumented to collect as much data as possible. As you might expect, these full-scale motors are very expensive and time consuming tests, we were only able to tests about one FSM per year on the RSRM program. The main purpose of the FSM changed somewhat from its original concept. Originally an FSM was going to be a flight unit taken off the line and tested to totally represent the other units being manufactured during the same time period. The FSM necessarily evolved to being the “Change Precursor”—many of the required changes on the RSRM Program (mostly obsolescence driven) required tests on full-scale static motors prior to flight. Our desire was to test all changes on static tests before flight. Part of the NASA culture to “test what you fly, fly what you test” was a derivative of the RSRM Program. It is this attention to testing coupled with an intensive post-fire inspection and intensive postflight inspection of all flight hardware and particular attention to process control makes up for the inability to green-run the RSRM.

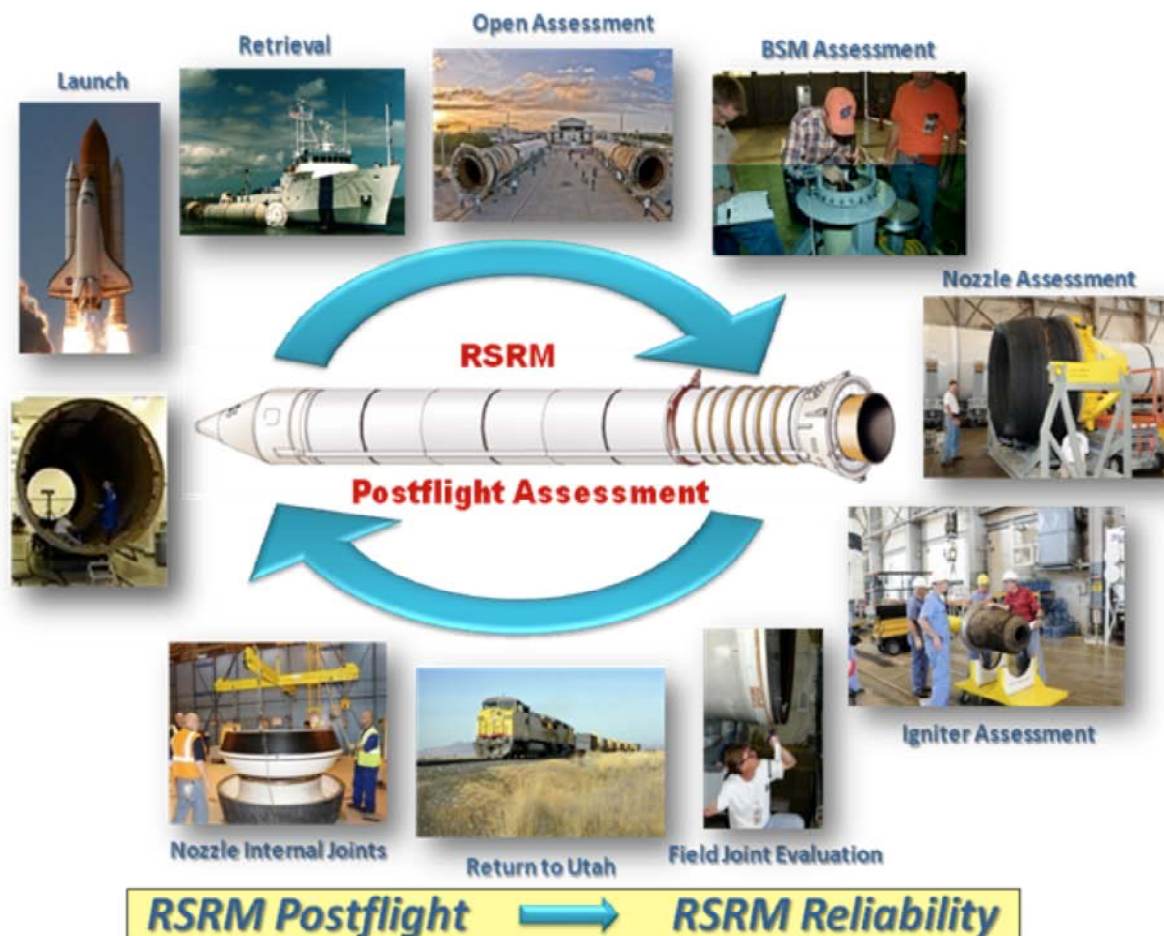
Figure 25. RSRM postflight.

Another key element of maintaining RSRM flight safety was the amount of emphasis placed on postflight/post-fire inspections.⁶ The rigor and detail applied to RSRM inspections is unique to the SRM industry. It was rather fortunate on the Space Shuttle Program for the decision to recover the SRBs after each Space Shuttle launch and refurbish the hardware to maximize reusability. The decision to recover the hardware permitted a detailed assessment of the hardware during the disassembly process. At the completion of first stage of a Space Shuttle Launch, the SRB separate from the vehicle and parachute down and land in the Atlantic Ocean about 100 miles off-shore from the launch site. The SRBs are retrieved by the Booster Recovery Ships, Liberty Star and Freedom Star. The ships' crews recover the SRBs and return them to Kennedy Space Center for safing, disassembly, and to undergo postflight inspection. For each Space Shuttle launch we send a crew of RSRM Design Engineers, Manufacturing Engineers, and Quality Engineers responsible for the hardware both from ATK Utah and from Marshall Space Flight Center to inspect and evaluate the performance of the hardware during hardware disassembly and document hardware condition (Fig. 25). Any unusual or unexpected conditions are given special attention and all require disposition prior to the next Space Shuttle Launch. There was a disciplined approach for identifying, evaluating, and dispositioning any In-Flight Anomalies (IFAs) or any reportable conditions. Even small performance differences are noted and require disposition. The same types of inspections are performed after an RSRM Flight Support Motor (FSM) static test fire with the same rigor applied. Any first flight or first test engineering changes are noted in a special issues document for the postflight/post-fire inspectors' review prior to performing inspections. The performance of the hardware relative to any engineering change made was always thoroughly evaluated and documented. At the time of this print, no other SRMs, current or previous, had this degree of detailed postflight inspection.
